Manhole Inspection Summary

Manhole # S21Y__009MH

Insp Date: **11/21/08 1:15 PM**

Location Address: **2102 MAISEL ST**

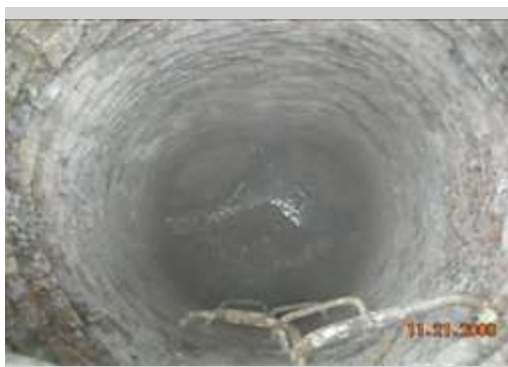
Defect 5

Count: **7** Missing: **0** ☒ **Corroded**

corroded steps

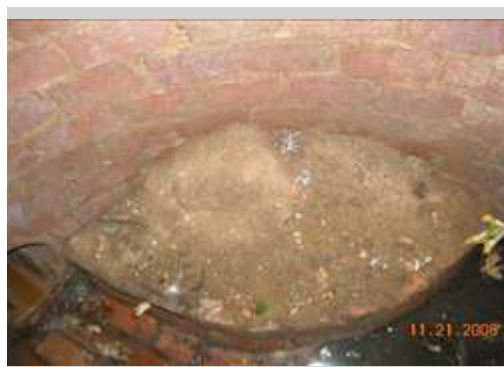
Defect 4

Condition: ☐ Sound ☐ Cracked ☐ Root Intrusion ☐ Deteriorated ☐ Leaks ☒ **Debris**

DEBRIS ON BENCH

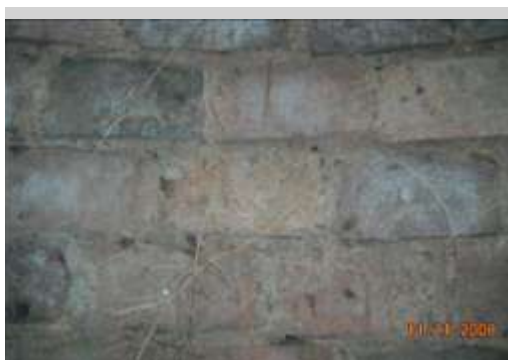
Defect 3

Condition: ☐ Sound ☐ Cracked ☒ **Root Intrusion** ☐ Loose Brick ☐ Deteriorated

BARREL ROOT INTRUSION

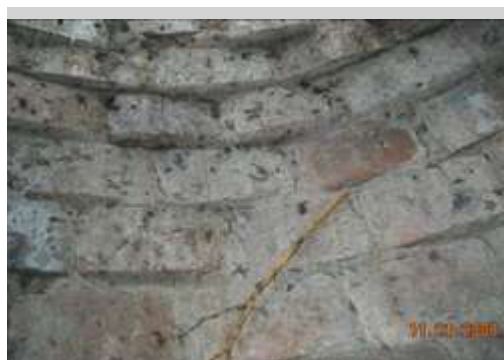
Defect 2

Condition: ☐ Sound ☐ Cracked ☒ **Root Intrusion** ☐ Loose Brick ☐ Deteriorated

CORBEL ROOT INTRUSION

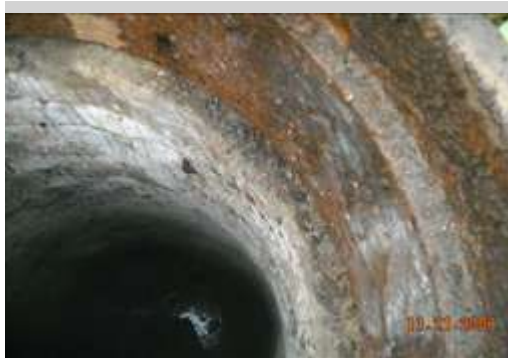
Defect 1

Offset: **1** (in.)

FRAME OFFSET

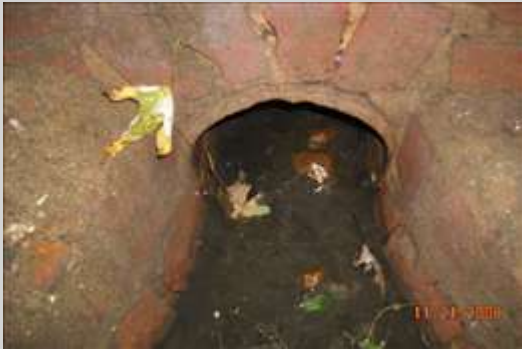
12 O'Clock Outflow

Pipe Height: **8.4** (in.) Rod and Bar (Angled)
Pipe Material: **Clay** ☐ Pipe Lined
Invert Depth: **12.08** (ft.) Flow Characteristics: **Slow**
Deposits: ☐ None ☒ **Mud** ☐ Sludge ☐ Debris ☐ Grease
Silt Depth: **2** (in.) Deposits Extent: **Light**
Infiltration: **None** Pipe Seal Cond: **Sound**

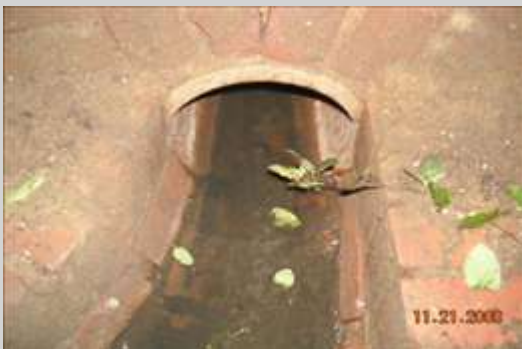
3 O'Clock Inflow

Pipe Height: **8.4** (in.) Rod and Bar (Angled)
Pipe Material: **Clay** ☐ Pipe Lined
Invert Depth: **12.03** (ft.) Flow Characteristics: **Slow**
Deposits: ☐ None ☒ **Mud** ☐ Sludge ☐ Debris ☐ Grease
Silt Depth: **1** (in.) Deposits Extent: **Light**
Infiltration: **None** Pipe Seal Cond: **Sound**
